## Monitoring Data Record

Project Title: R-2719A Crescent Road COE Action ID: 200802460
WQC Number: 003763
Stream Name: UT to Falling Creek
City, County and other Location Information: <u>UT to Falling Creek is located on US 70 just west of</u>
the C.F. Harvey Parkway interchange in Kinston, Lenoir Co.
Date Construction Completed: 3/3/11 Monitoring Year: (5) of 5
Ecoregion: Southeastern Floodplains and Low Terraces 8 digit HUC unit 03020202
USGS Quad Name and Coordinates: 35.261881, -77.683669
Rosgen Classification: E5
Length of Project: 2,393' Urban or Rural: Rural Watershed Size: 0.5 sq. miles
Monitoring DATA collected by: M. Green, N. Shah, B. Bradley
Date: 6/28/16
Applicant Information:
Name: NCDOT Roadside Environmental Unit
Address: 1425 Rock Quarry Road Raleigh, NC 27610
Telephone Number: (919) 861-3772 Email address: mlgreen@ncdot.gov
Consultant Information:
Name:Address:
Telephone Number: Email address:
Project Status: Complete

# UT to Falling Creek

Year 5 Summer – June 2016

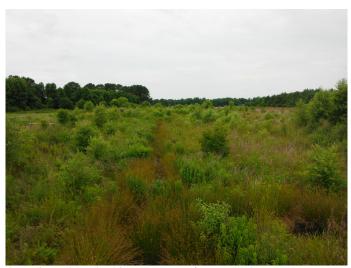
Overview photo looking upstream from US 70
